Reserve Study Update

Magdalena Gardens Condominium Association, Inc.

240 West End Drive
Punta Gorda, FL 33950

Prepared on:
10/5/2021

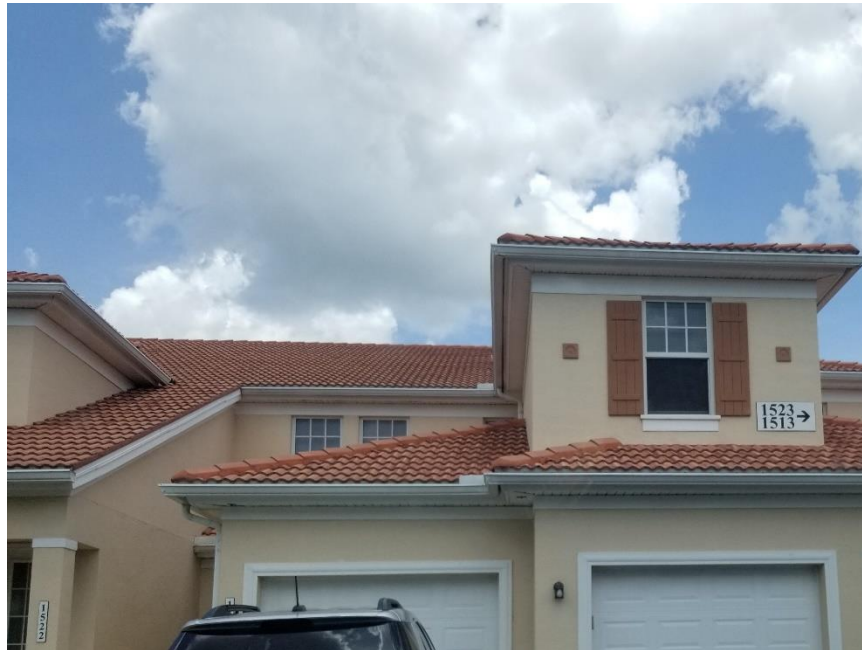
Tile Roof (Typical)

The roof for all 15 structures and the pool house at Magdalena Gardens is barrel tile. The existing tile roofs are original which makes them about 13 years old. Consult is not aware of any major problems with the existing roofing system. Consult recommends that the roofs be regularly inspected by a qualified professional. This line item includes pricing for replacement of the roof only.

TILE ROOF	ESTIMATED USEFUL LIFE	ESTIMATED REMAINING LIFE	ESTIMATED CURRENT REPLACEMENT COST
	25	11	\$1,290,096

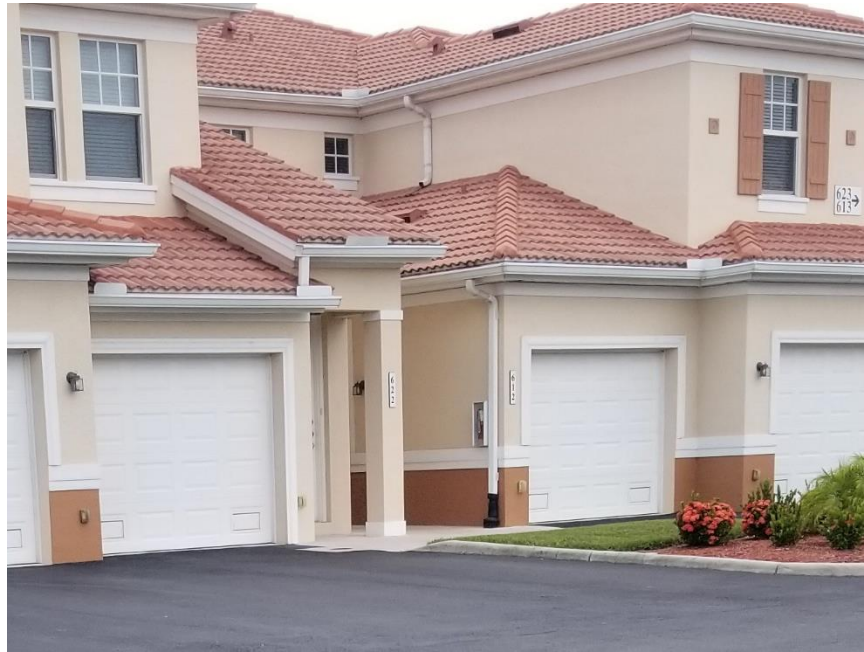
Tile Roof (Typical)

The soffit and fascia at Magdalena Gardens are found where the roof terminates on each building. This line item is for replacement.

SOFFIT AND FACIA	ESTIMATED USEFUL LIFE	ESTIMATED REMAINING LIFE	ESTIMATED CURRENT REPLACEMENT COST
	25	11	\$141,372

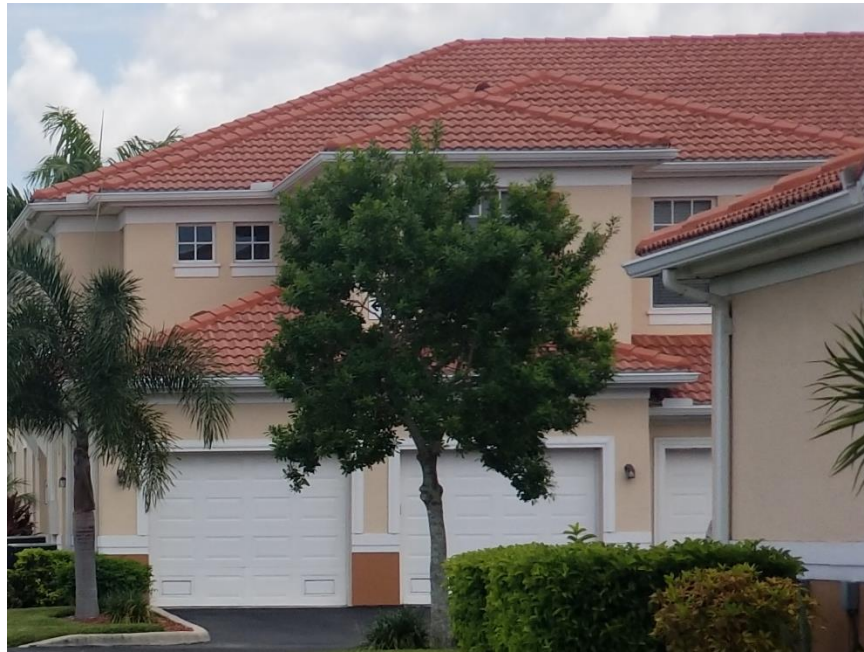
Gutters & Downspouts (Typical)

Each of the 15 buildings at Magdalena Gardens have gutters that wrap around the perimeter of the building on two stories. The downspouts are in appropriate locations.

GUTTERS & DOWNSPOUTS	ESTIMATED USEFUL LIFE	ESTIMATED REMAINING LIFE	ESTIMATED CURRENT REPLACEMENT COST
	25	14	\$121,176

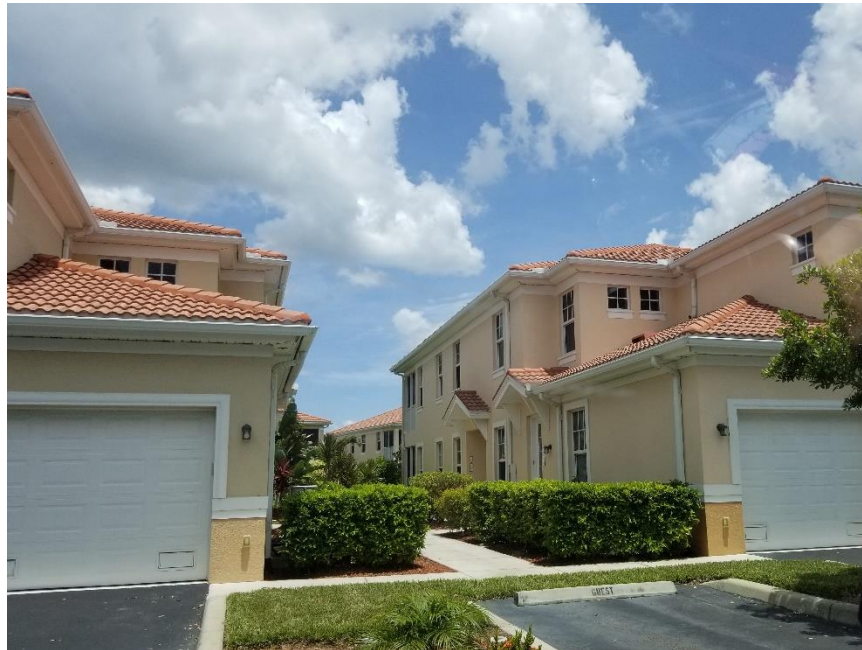
Building Exterior (Typical)

The painted surfaces at Magdalena Gardens appear to be in a condition consistent with its age. The Association should maintain a regular painting schedule. Consult recommends a regular painting schedule of 7 years that coincides with the durability and warranty of the paint. This line item includes the painting of the buildings and pool cabana.

EXTERIOR PAINTING	ESTIMATED USEFUL LIFE	ESTIMATED REMAINING LIFE	ESTIMATED CURRENT REPLACEMENT COST
	7	2	\$107,100

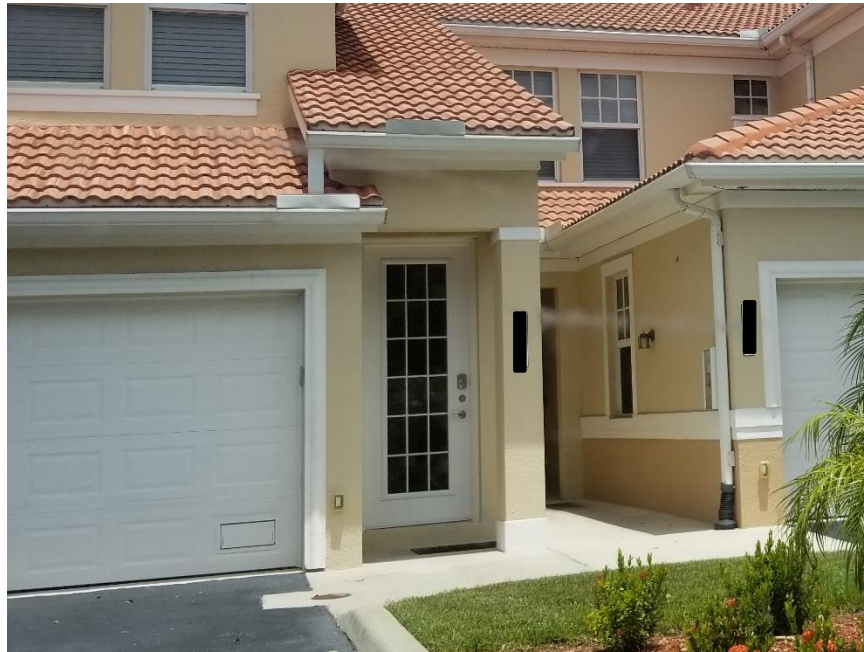
Front Entry Door (Typical)

Each unit at Magdalena Gardens has a front and bedroom entry door. This line item is for replacement.

FRONT AND BEDROOM ENTRY DOORS	ESTIMATED USEFUL LIFE	ESTIMATED REMAINING LIFE	ESTIMATED CURRENT REPLACEMENT COST
	20	9	\$183,600

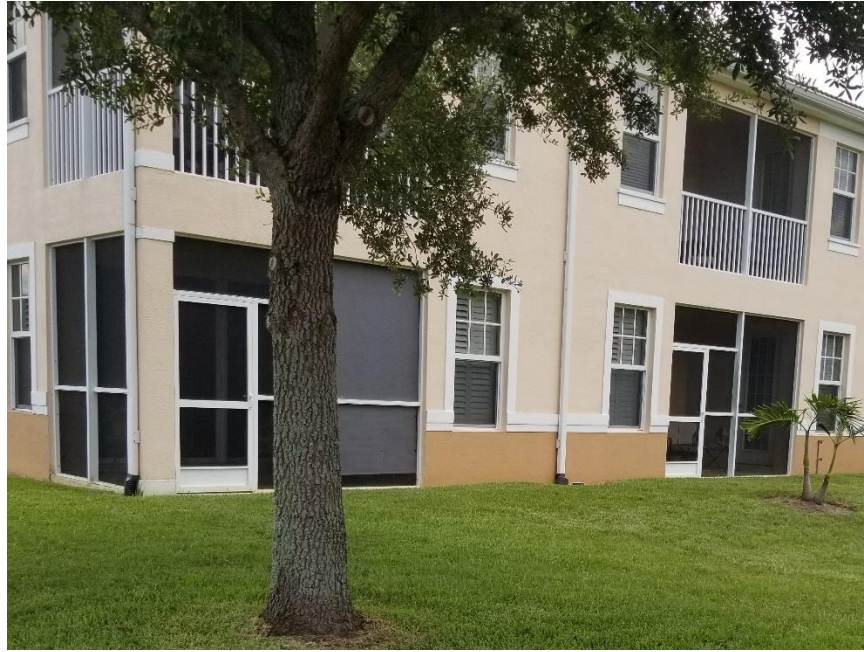
Unit Screen Enclosure (Typical)

LANAI SCREEN ENCLOSURE	ESTIMATED USEFUL LIFE	ESTIMATED REMAINING LIFE	ESTIMATED CURRENT REPLACEMENT COST
	20	6	\$220,320

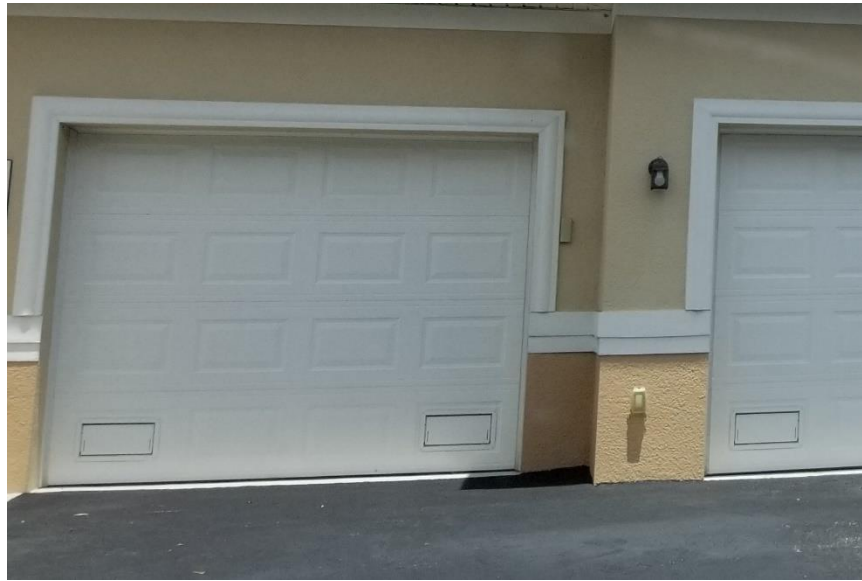
Garage Doors (Typical)

Magdalena Gardens has 90 garage doors, one for each unit. They have two hydrostatic vents in case of flooding.

GARAGE DOORS	ESTIMATED USEFUL LIFE	ESTIMATED REMAINING LIFE	ESTIMATED CURRENT REPLACEMENT COST
	20	7	\$82,620

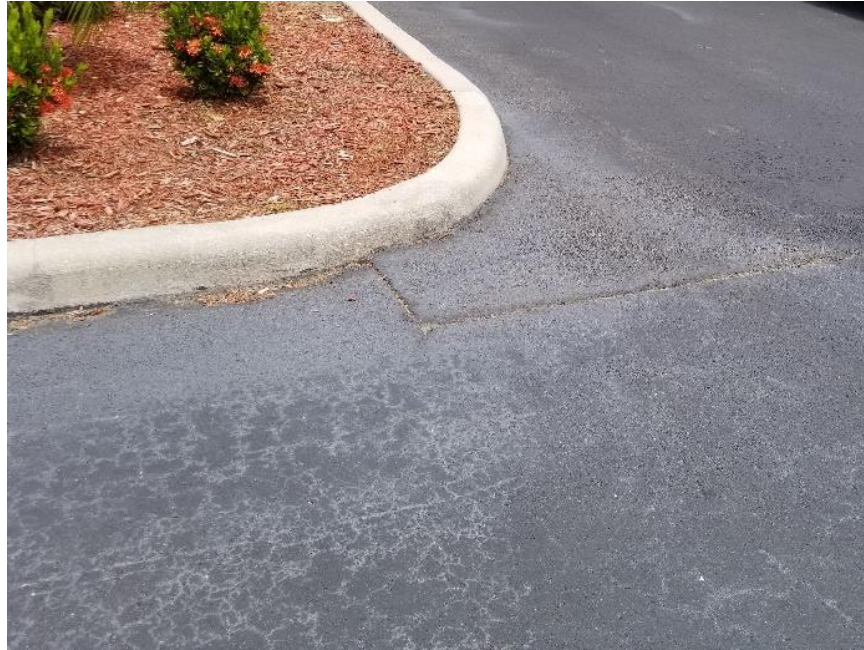
Alligator Cracking and Raveling in Drive (Typical)

Seal coating is done every 3 to 5 years. Seal coating is advantageous for slowing raveling (the wearing away of surface aggregate), but it is mostly for curb appeal. Many problems that appear in asphalt are not because the topcoat has degraded, but because the substrate is less than ideal. The cracks that are seen at the surface are reflective of the deficiencies at the bottom of the asphalt layer making a seal coat ineffective at maintaining aged asphalt. On the other hand, seal coating does have advantages like discouraging seepage of water, oil and other chemicals into the asphalt base.

PAVEMANT SEALCOAT	ESTIMATED USEFUL LIFE	ESTIMATED REMAINING LIFE	ESTIMATED CURRENT REPLACEMENT COST
	3	3	\$10,050

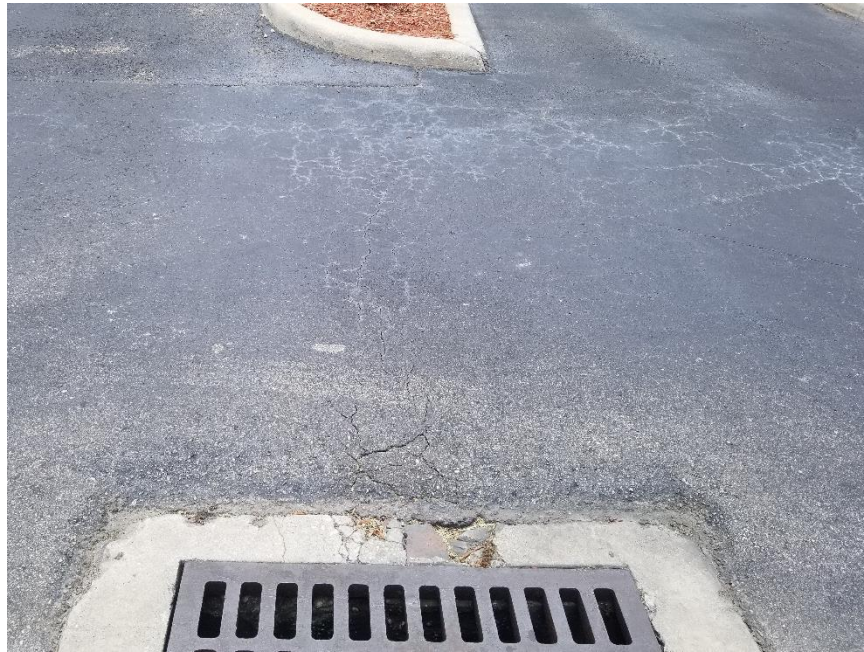
Alligator Cracking (Typical)

Tear-out and replacement is the process of removing all existing asphalt, putting down a new layer of aggregate to level the substrate, and applying a new coat of asphalt. Problems resulting from a poor substrate can be addressed during this process.

Tear-out and replacement of the asphalt is recommended at the end of the remaining useful life in lieu of milling and resurfacing. If testing is conducted and it is determined that the asphalt can be successfully milled and resurfaced at the time of replacement, then the actual project costs are anticipated to be slightly lower.

TEAR-OUT & REPLACEMENT	ESTIMATED USEFUL LIFE	ESTIMATED REMAINING LIFE	ESTIMATED CURRENT REPLACEMENT COST
	25	9	\$85,760

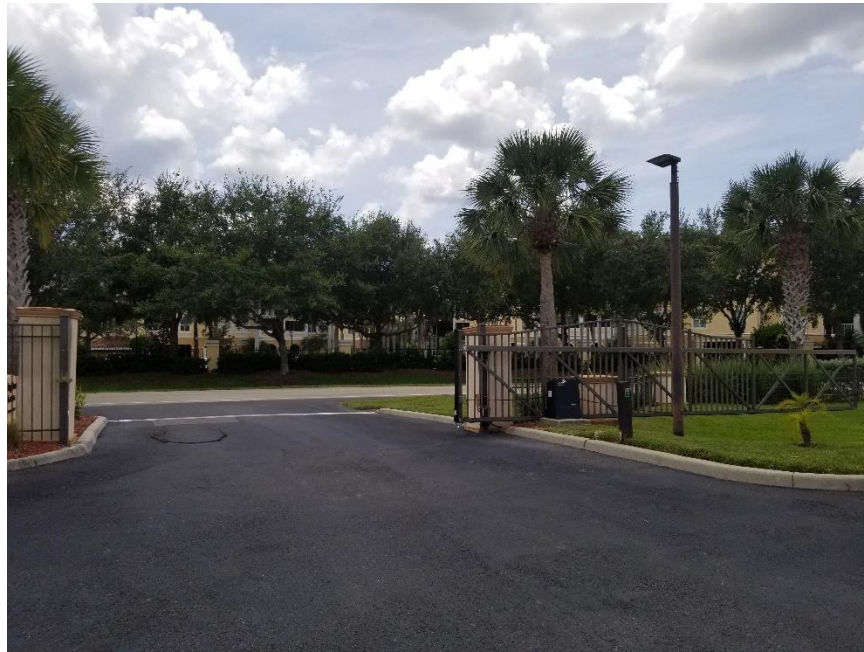
Main Entrance with a Rolling Gate (Typical)

Magdalena Gardens has two rolling gates as the main entry and exit points connecting to West End Drive. They were recently repaired in 2017 along with the installation of new motorized operators.

MAIN GATES (ROLLING)	ESTIMATED USEFUL LIFE	ESTIMATED REMAINING LIFE	ESTIMATED CURRENT REPLACEMENT COST
	15	6	\$6,120

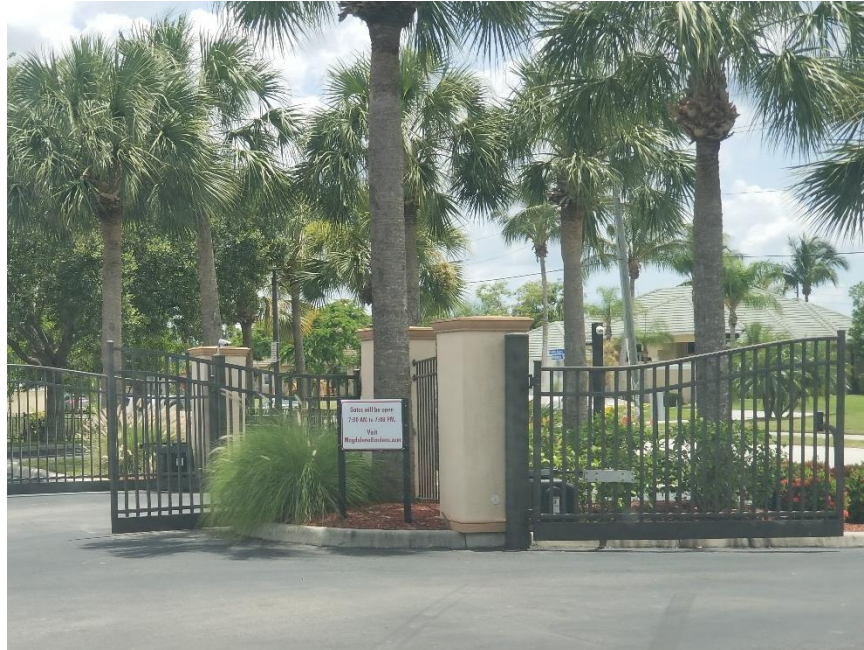
Side Entrance with Swing Gate (Typical)

SIDE GATES (SWING)	ESTIMATED USEFUL LIFE	ESTIMATED REMAINING LIFE	ESTIMATED CURRENT REPLACEMENT COST
	15	6	\$10,200

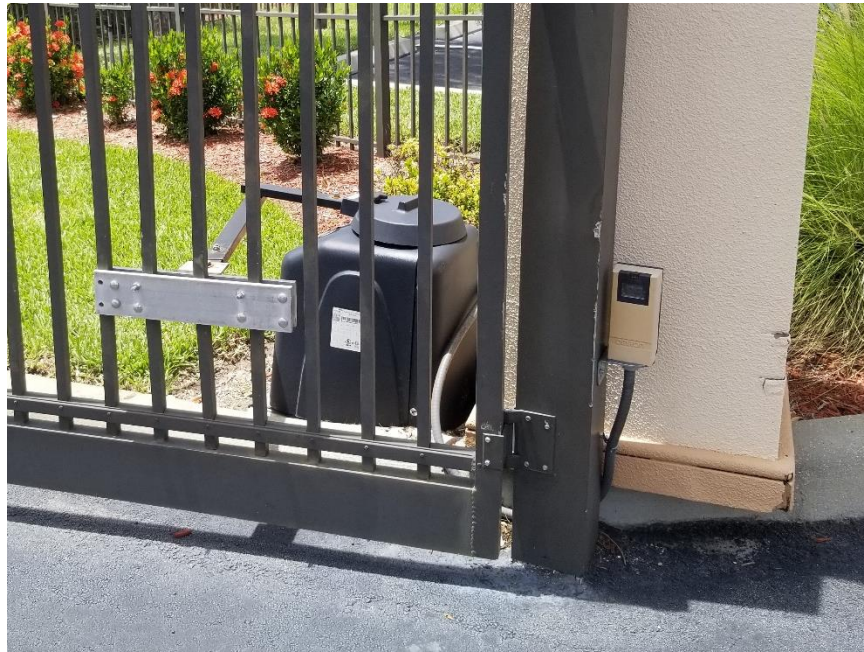
Motorized Opener (Typical)

Each automatic gate requires the use of a motor. They are indiscreet and protected from the weather. Typical features include a battery back-up, a temperature management system, and surge protection.

MOTORIZED OPENERS	ESTIMATED USEFUL LIFE	ESTIMATED REMAINING LIFE	ESTIMATED CURRENT REPLACEMENT COST
	10	6	\$22,644

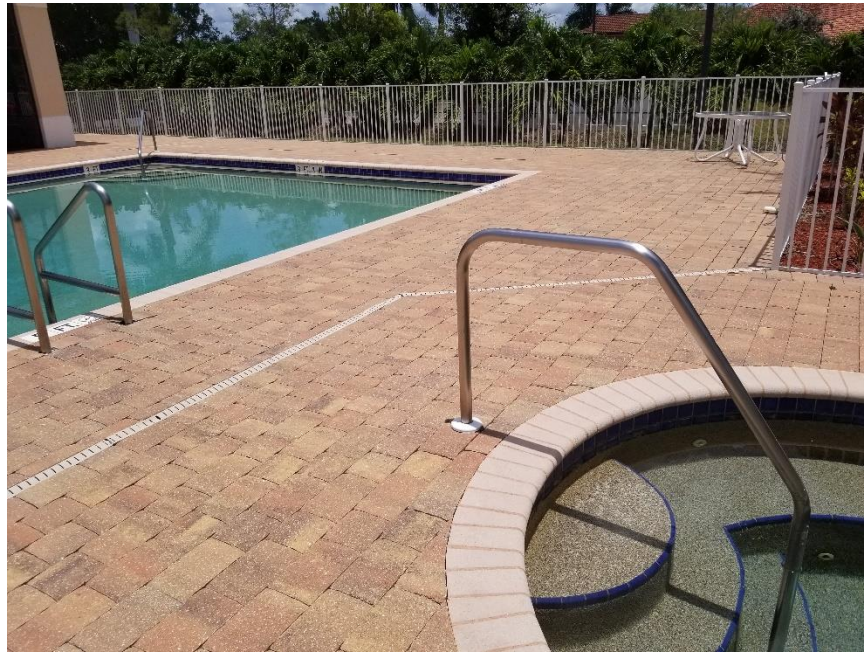
Pool & Spa (Typical)

Magdalena Gardens has a 25' x 45' rectangular pool and detached spa. The pool and spa finished surfaces appear to be in a condition consistent with its age.

RESURFACE POOL & SPA	ESTIMATED USEFUL LIFE	ESTIMATED REMAINING LIFE	ESTIMATED CURRENT REPLACEMENT COST
	15	15	\$32,000

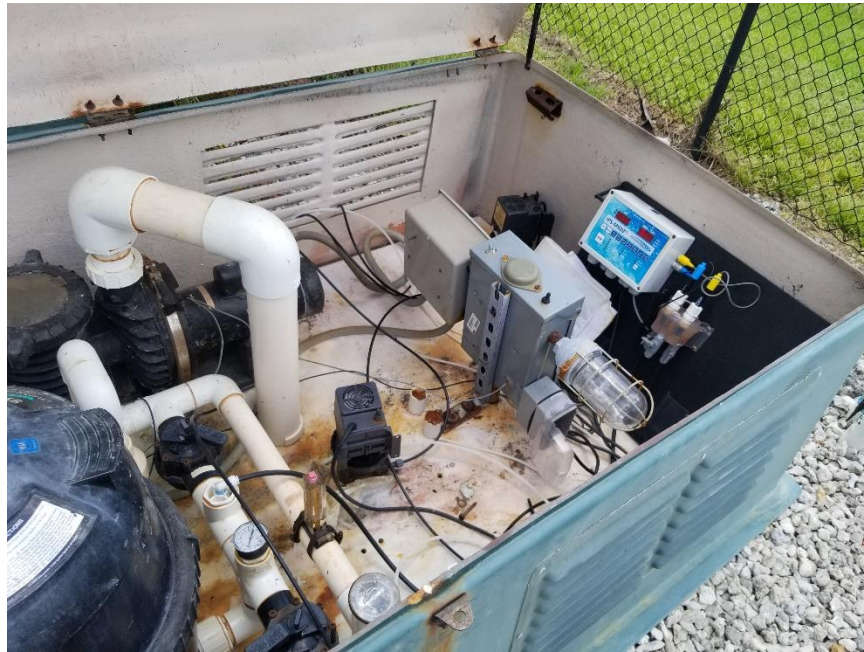
Pool Equipment (Typical)

Pool equipment can vary and typically does not fall within the \$10,000 threshold to include in a Reserve account. This being said, by combining the equipment costs together, the \$10,000 threshold can easily be reached and exceeded. Pool equipment does not need replacement at the same time so this line item becomes an allowance that will be used over the estimated life expectancy of the equipment.

EQUIPMENT ALLOWANCE	ESTIMATED USEFUL LIFE	ESTIMATED REMAINING LIFE	ESTIMATED CURRENT REPLACEMENT COST
	10	4	\$18,360

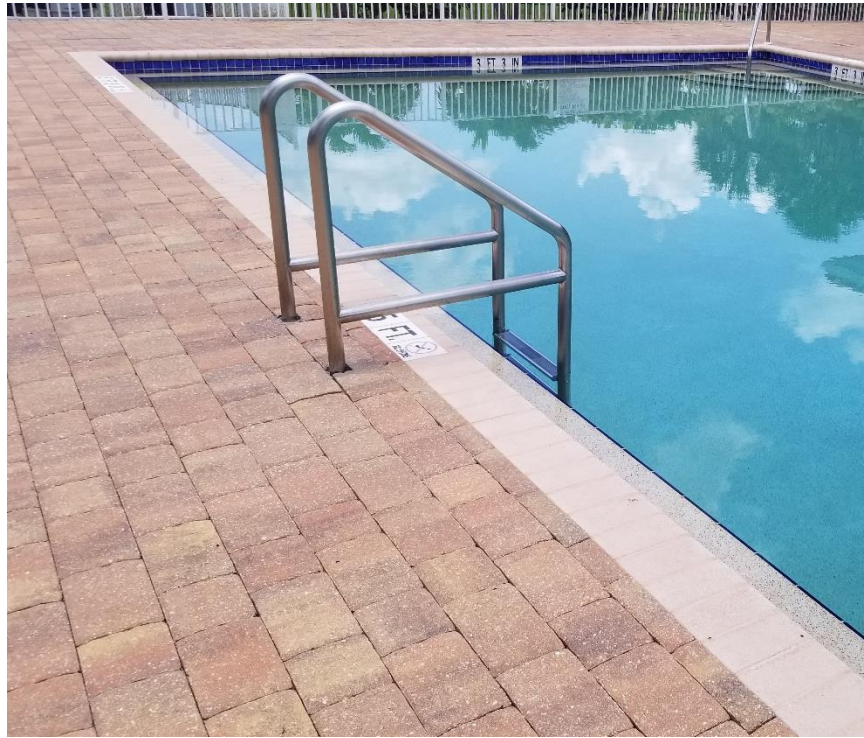
Pool Deck Pavers (Typical)

The interlocking pool deck pavers at Magdalena Gardens appear consist with their age. The pool's coping is made up of painted bullnose pavers. This line item is for total replacement of the pool deck pavers.

POOL DECK PAVERS	ESTIMATED USEFUL LIFE	ESTIMATED REMAINING LIFE	ESTIMATED CURRENT REPLACEMENT COST
	20	6	\$24,709

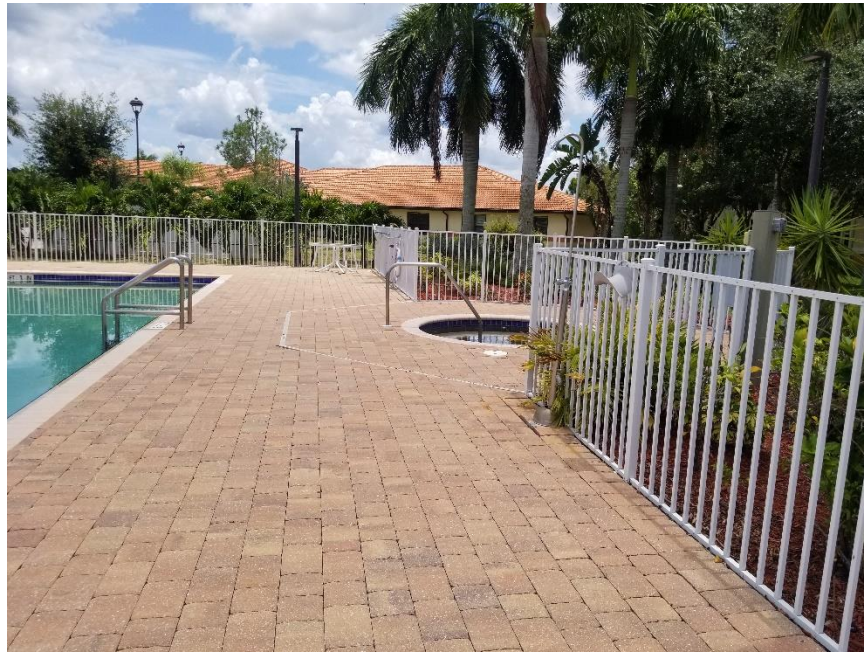
Pool Railings (Typical)

The pool fencing at Magdalena Gardens appears consists with its age and shows little signs of corrosion.

POOL FENCING	ESTIMATED USEFUL LIFE	ESTIMATED REMAINING LIFE	ESTIMATED CURRENT REPLACEMENT COST
	20	8	\$32,538

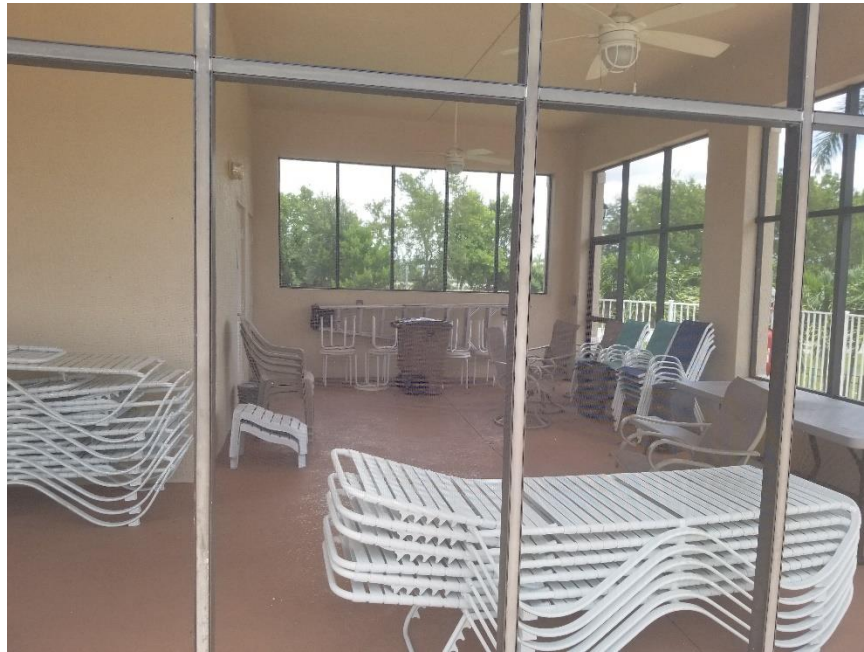
Pool Furniture (Typical)

The pool at Magdalena Gardens has tables, chairs, and chaise lounges available for around the pool and the cabana. This line item is an allowance to repair and replace the pool furniture as needed.

POOL FURNISHINGS & RECREATIONAL EQUIPMENT	ESTIMATED USEFUL LIFE	ESTIMATED REMAINING LIFE	ESTIMATED CURRENT REPLACEMENT COST
	15	6	\$15,000

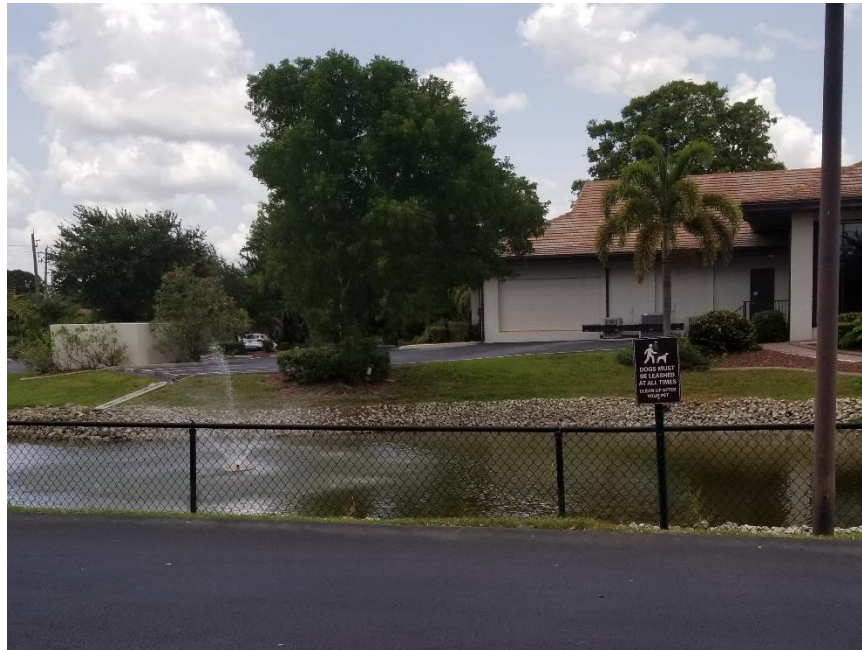
Chain-link Fence 4' (Typical)

CHAIN-LINK FENCE 3'	ESTIMATED USEFUL LIFE	ESTIMATED REMAINING LIFE	ESTIMATED CURRENT REPLACEMENT COST
	20	6	\$7,180

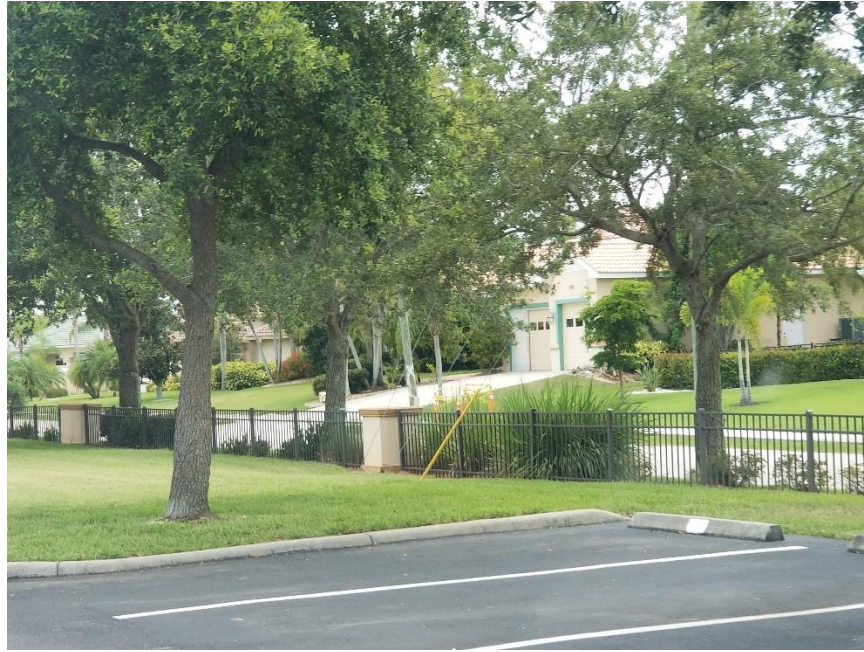
Perimeter Fence w/ Monuments (Typical)

Magdalena Gardens has approximately 1,445 LF of aluminum perimeter fencing with faux concrete columns roughly every 50'. This line item is for major repairs at the end of its useful life. With proper maintenance, this duration could be extended due to the durability, initial installation and maintenance of the materials. The aluminum fencing was recently painted this year and the monuments were also repaired, reinforced and repainted.

PERIMETER FENCING W/ MONUMENTS	ESTIMATED USEFUL LIFE	ESTIMATED REMAINING LIFE	ESTIMATED CURRENT REPLACEMENT COST
	25	15	\$170,972

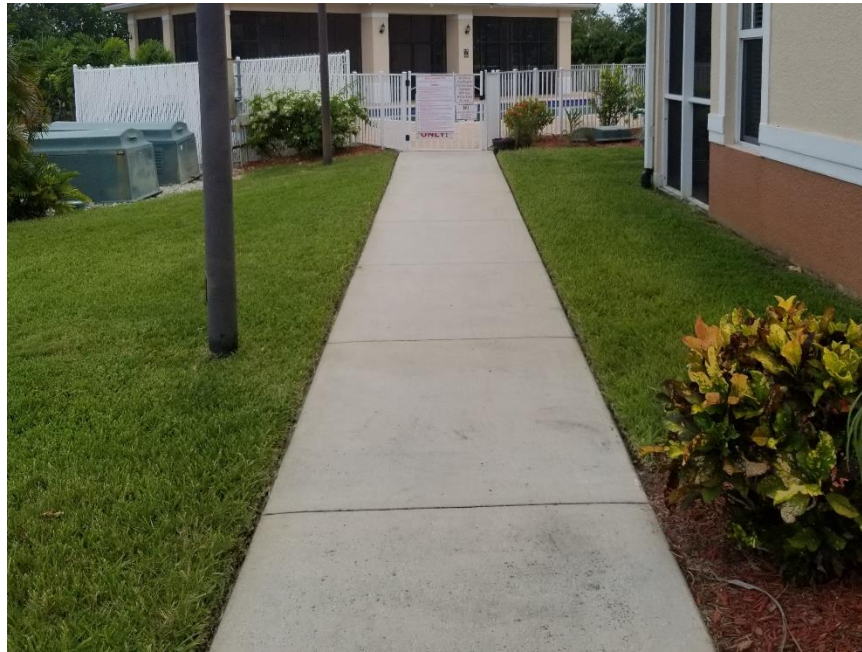
Concrete Sidewalk (Typical)

CONCRETE SIDEWALKS	ESTIMATED USEFUL LIFE	ESTIMATED REMAINING LIFE	ESTIMATED CURRENT REPLACEMENT COST
	30	17	\$77,520

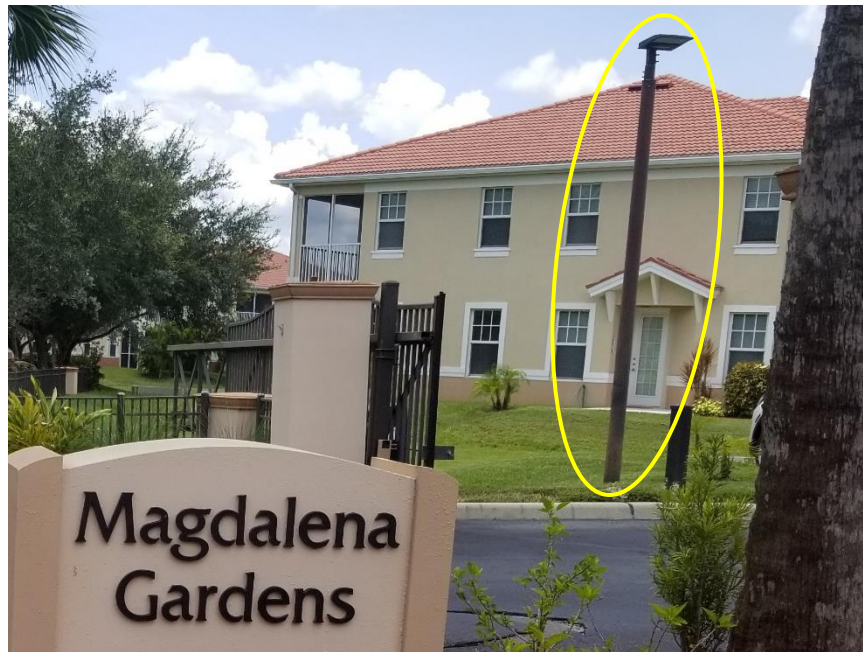
Light Pole (Typical)

Magdalena Gardens has 14 light poles spread throughout the property. This line item is for replacement and repairs as needed. All 14 light poles were repaired and repainted in 2020.

LIGHTING	ESTIMATED USEFUL LIFE	ESTIMATED REMAINING LIFE	ESTIMATED CURRENT REPLACEMENT COST
	20	10	\$15,708

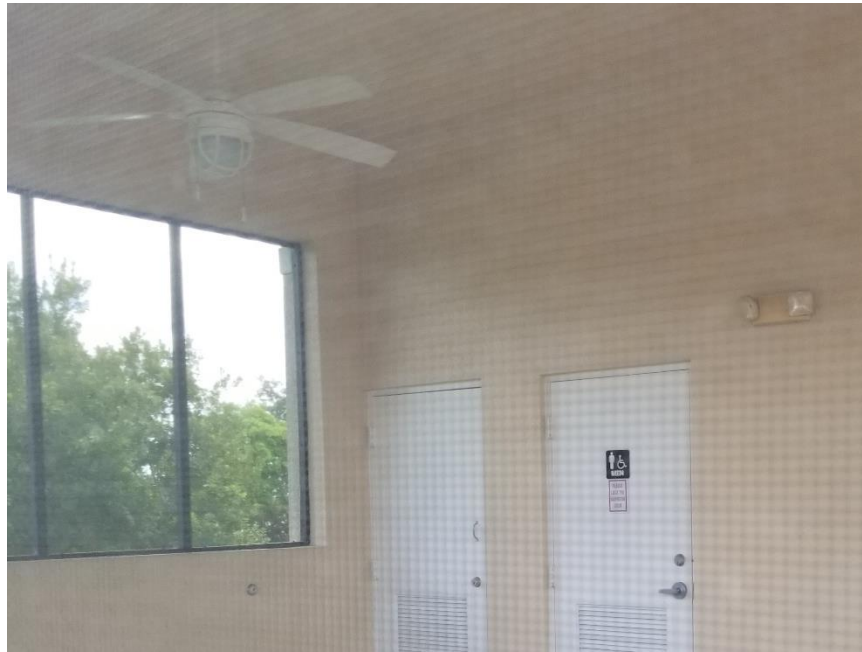
Cabana Fixtures (Typical)

Magdalena Gardens has 135 small exterior fixtures, 90 lanai ceiling fixtures, 6 pool cabana fixtures, and 120 exterior GFIs. This line item is for replacement of the fixtures.

ELECTRICAL ALLOWANCE	ESTIMATED USEFUL LIFE	ESTIMATED REMAINING LIFE	ESTIMATED CURRENT REPLACEMENT COST
	10	6	\$41,820

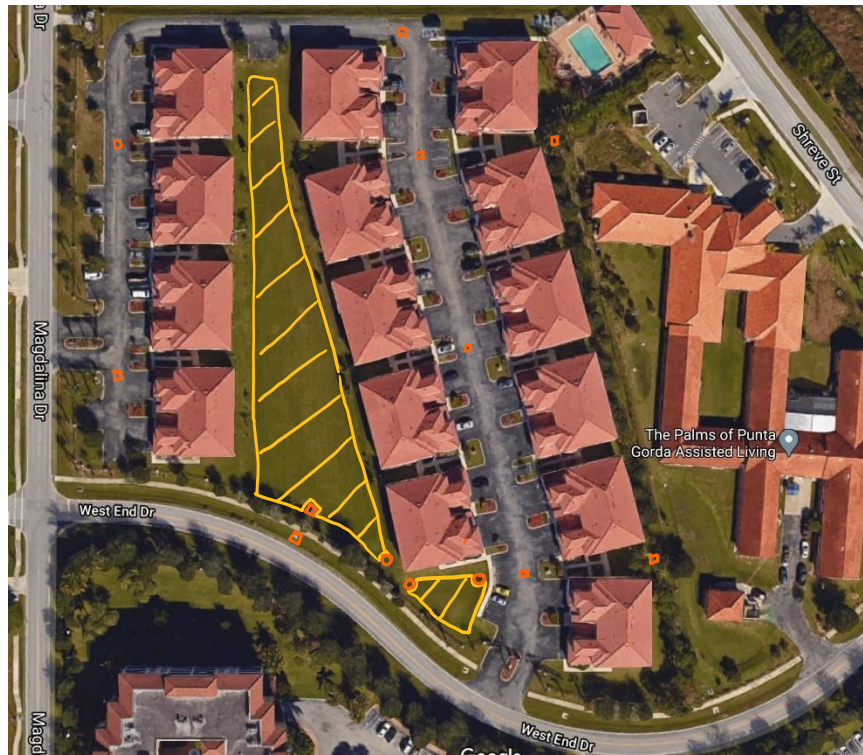
Ariel View of Drainage System

Consult previously studied the drainage around buildings 2 through 5 due to a standing water issue in 2018. The study found that the underground pipes were directing water away from the retention ponds in some areas. This issue was corrected in 2019. This line item includes pricing for maintenance of the entire drainage system.

DRAINAGE MAINTENANCE	ESTIMATED USEFUL LIFE	ESTIMATED REMAINING LIFE	ESTIMATED CURRENT REPLACEMENT COST
	15	13	\$34,782
